# Out of sight: Case studies of innovative *in situ* remediation under active industrial sites across Europe

Gareth Leonard (REGENESIS UK), Paola Gorla (REGENESIS Italy), Kris Maerten (REGENESIS Belgium)

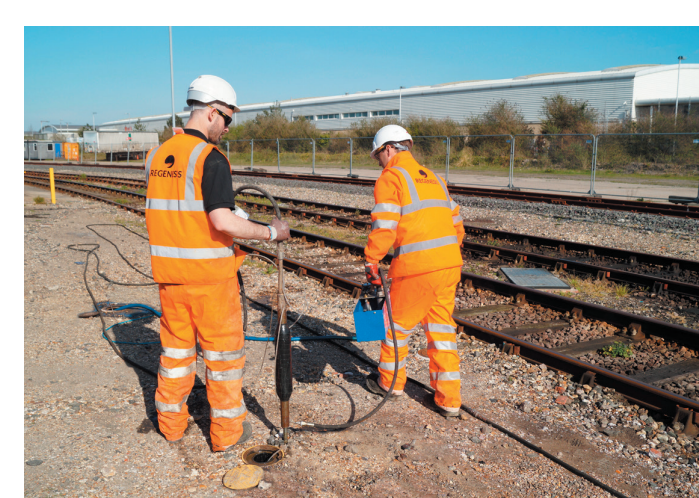
Fig.3 Source area with migrating plume

Remediation of free product under an active train care depot, where trains have been stored, repaired, cleaned and refilled for over 50 years. Due to fuel spill incidents, a 2m thick layer of LNAPL (Light Non-Aqueous Phase Liquid) was located on top of the groundwater column in the source area and with the contaminated plume migrating towards residential properties.

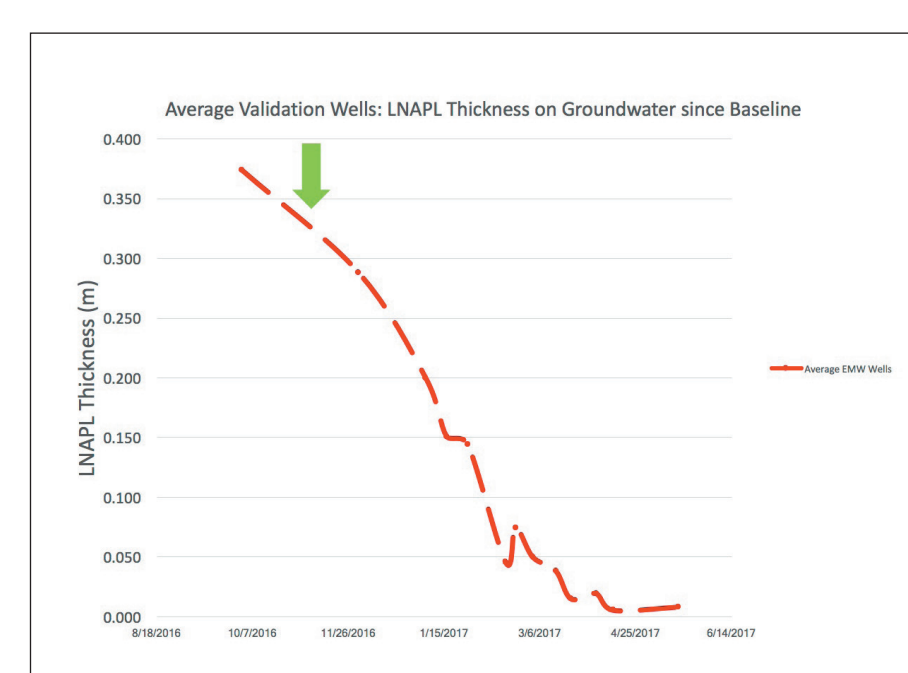
Fig. 4 Graph showing how the LNAPL thickness is reduced during pumping and increases due to enhanced desorption during PetroCleanze applications. It can be seen that the 'rebound' caused by each consecutive PetroCleanze injection is lower than the prior one, indicating a reduction in adsorbed contamination following each event

A pump & treat system was installed and operated to remove the easily-accessible LNAPL. Following this, four applications of PetroCleanze® were applied into the treatment wells. By using PetroCleanze, soil-bound contaminant mass moved from the smear zone into the groundwater, making it easily removable by the pump and treat system, thus avoiding any future rebound in concentrations, due to desorption, after the pump and treat system was switched off.

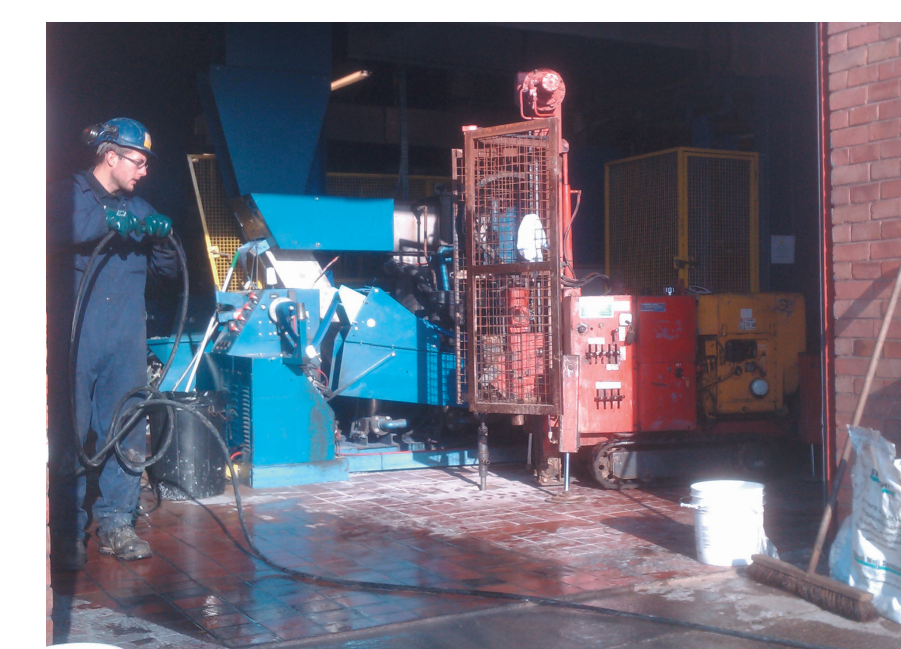
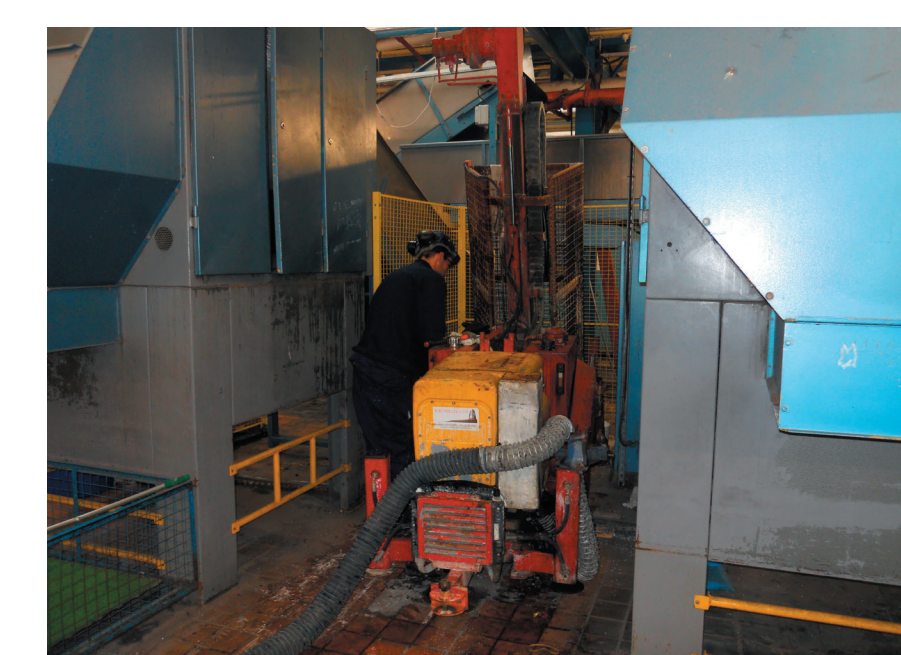
In the deep, low permeability clays, REGENESIS applied a combination of Hydrogen Release Compound (HRC) products (HRC Primer®, HRC® and HRC-X®). HRC is an engineered, hydrogen release compound designed specifically for enhanced, in situ anaerobic bioremediation of chlorinated compounds. The HRC product mix was injected with a direct push injection rig on a grid pattern across the target area. In the shallow, permeable made ground, the high-volume version of HRC, called 3-D Microemulsion (3DMe) was injected to enhance the anaerobic biodegradation of the chlorinated hydrocarbons. The injection was completed within two weeks, with no impact on the dry cleaning operations.

A spill during delivery of dry cleaning fluid, caused the ground beneath an industrial dry cleaning facility to be contaminated with up to 2 tonnes of Tetrachloroethene (PCE). Groundwater and soil up to 10m below ground levels were significantly polluted.

- Chlorinated solvent contamination was found in shallow permeable soils and deep in low permeable clays beneath the site
- There was evidence of DNAPL in more sandy layers within the clay
- Treatment was required in the busy outside yard and inside under the active machinery of the facility
- The contamination was moving offsite in an aerobic aquifer, showing no natural signs of biological degradation
