# CHARATERIZATION OF THE IMPACT OF HEAVY METAL POLLUTION ON SURFACE WATER BODIES AS RESULT OF THE REGIONAL DIFFUSE SOIL AND GROUNDWATER POLLUTION IN THE CAMPINE AREA (NE BELGIUM)

J. Bronders<sup>(1,5)</sup>, I. Van Keer<sup>(1)</sup>, J. Vos<sup>(1)</sup>, N. Desmet<sup>(1)</sup>, I. Joris<sup>(1)</sup>, J. Patyn<sup>(1)</sup>, D. Paulus<sup>(2)</sup>, T. Lieben<sup>(3)</sup>, P. De Clercq<sup>(3)</sup>, A. Van Autenboer<sup>(4)</sup>

(1) VITO Belgium; (2) Tauw Belgium; (3) OVAM Belgium; (4) SWECO Belgium  
(5) contact: jan.bronders@vito.be

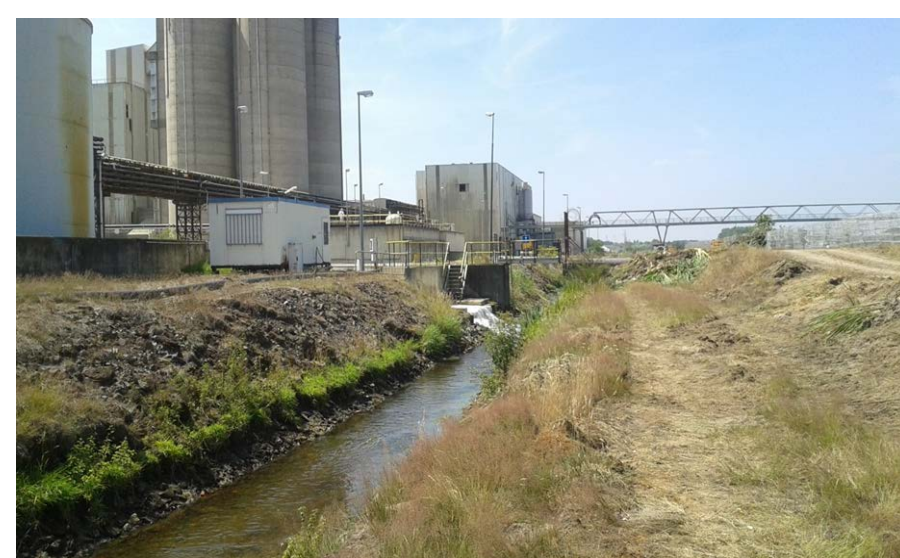
River banks containing Zinc ashes, causing surface water pollution through erosion

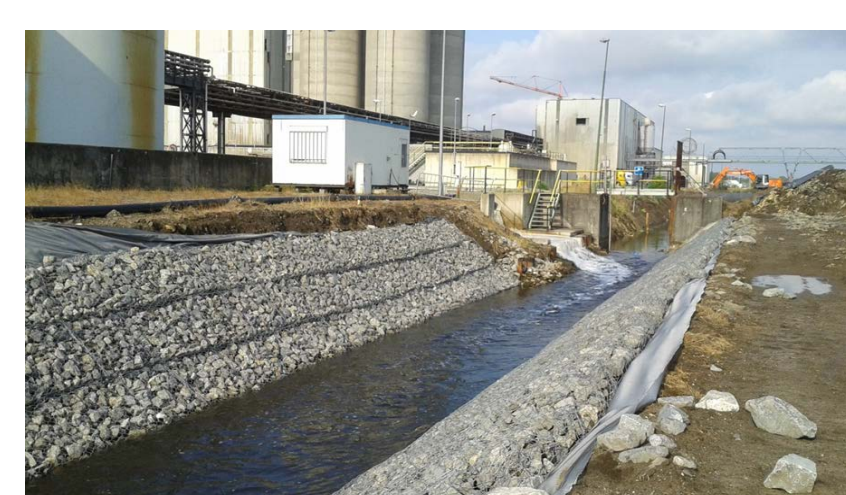
Covered river bank: after removal of 40 cm of ashes, a geotextile and gabion cages prevent contamination of the surface water

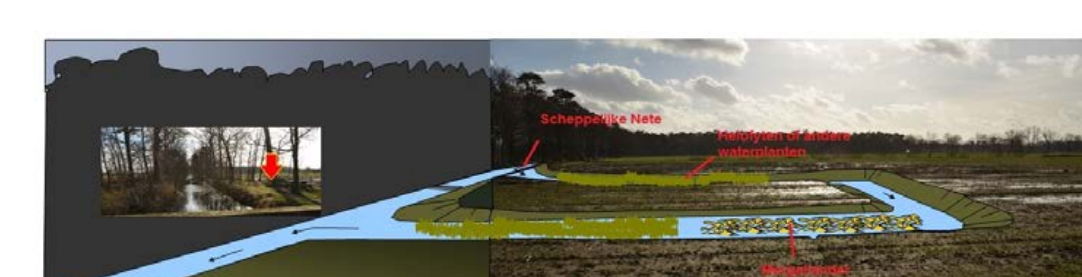
Passive treatment of surface water using absorbentia
